# **Qualitative Assessment for the Pete King Project Area Streams Using Proper Functioning Condition Approach (PFC) 2019**

## **Introduction**

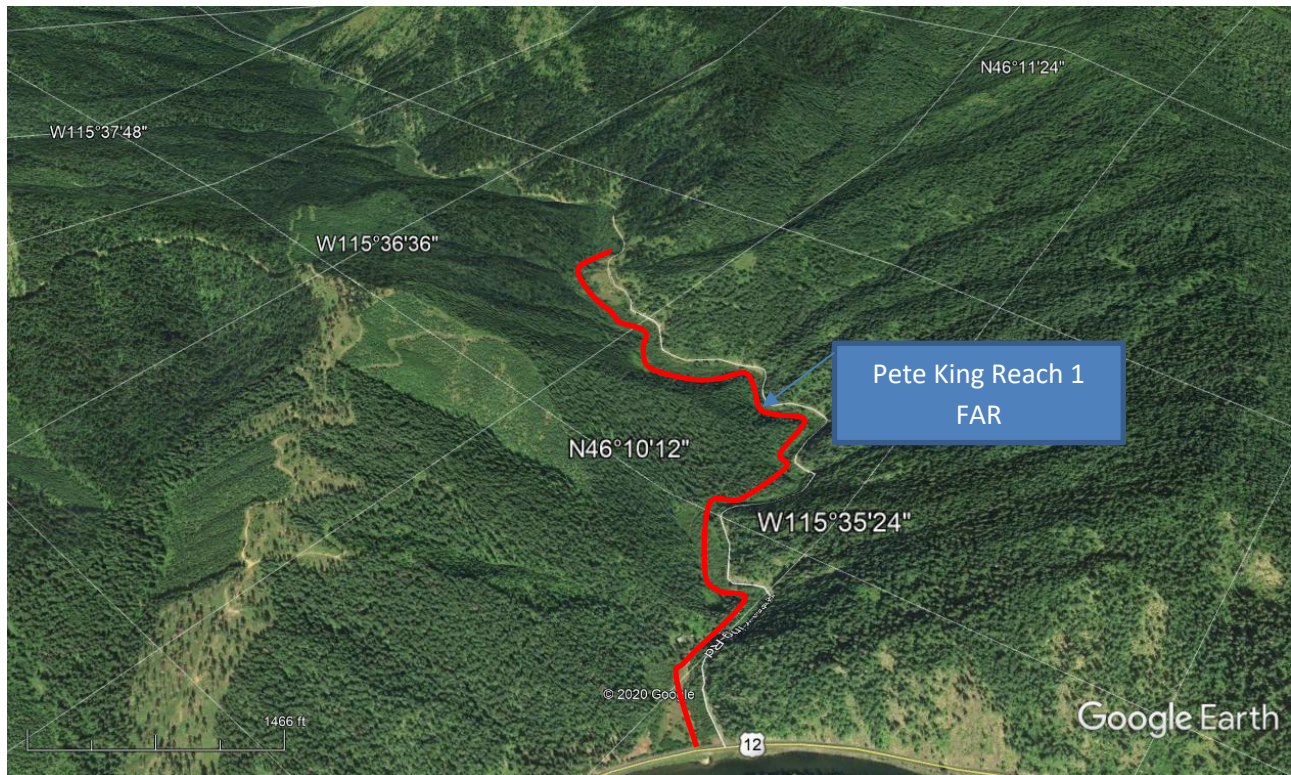
**Assessed Reach 1 (~9650ft):** This reach flows through private land in the lower end and directly into the Lochsa River however most of the reach is on Forest Service Managed lands. The reach appears to have had some selective riparian harvest previously given old cedar stumps noted during the field survey. This harvest is estimated at well over 50 (estimated during the 1960s or 70s) years ago long before modern riparian buffers were required. Residual materials derived from resistant rock types such as colluvium and or alluvium adds significant control and adequate sources of existing and recruitment of large wood (LWD) as well as healthy amounts of riparian-wetland vegetation has help maintain channel/stream bank stability. This reach and will most likely remain resistant to large scale evulsions and catastrophic disturbances such as large flood events (Photo 2, 3 and 5). There is enough channel and floodplain vegetation, soils or land form characteristics to withstand large flood events without significantly damaging the riparian corridor. Channel in confined in areas due to valley form. The channel is relatively stable vertically and laterally (photo 1, 2, 3, 4 and 5) which means it has limited ability to laterally scour and or vertically scour or down-cut. The channel type of this reach is primarily a Rosgen "C/B". Channel slopes for this type typically range from 3-8%, substrate ranges from cobbles and boulders to a mix of gravels and small gravel alluvium. No major evulsions or aggradation of bedload were observed. The stream habitat in this reach is influenced heavily by large woody debris which has produced scour pools and riffles. Large woody debris (LWD) and riparian vegetation is an integral part of this type of stream system. LWD and riparian vegetation dissipates erosive energy, controls bedload transport, stabilizes stream channels, and creates suitable habitat for fish and other aquatic organisms. Vegetated point bars and substrate indicate stable hydrologic process. The stream channel is shaded mostly by a dense over-story of mature deciduous trees and brush but limited adjacent LWD recruitment. In summary this stream channel reach, just below the project area and therefore most subject to effects, should remain in a stabilized condition and should continue to improving in complexity and stability over time and trend toward desired conditions for aquatic habitat (i.e. embeddedness) as existing fine sediments move out of the system and minimal fines are input. The fish habitat suitability (pools, complexity, clean water and shade) in this reach should be maintained or improved over time given the protective riparian buffers which will remain intact.

This reach is rated as **Functioning at Risk (FAR) with No Apparent Trend:** Due to the existence of the adjacent forest road which limits flood plain controls and dynamics, limited LWD recruitment in the lower end of the reach and available alluvial stream bank material.

Photo 1: Pete King Creek Assessment Reach 1 (46°10'15.21" N 115°35'33.80" W)

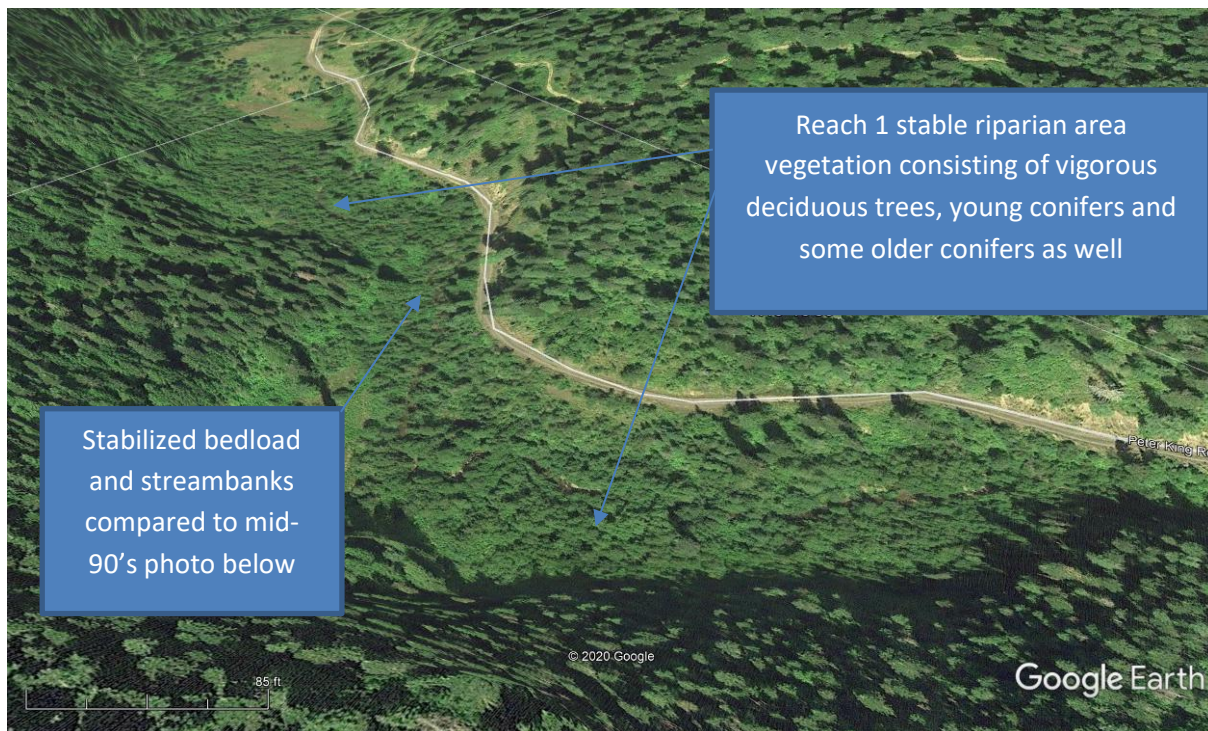
Photo 2: Pete King Creek Assessment Reach 1 future LWD recruitment.

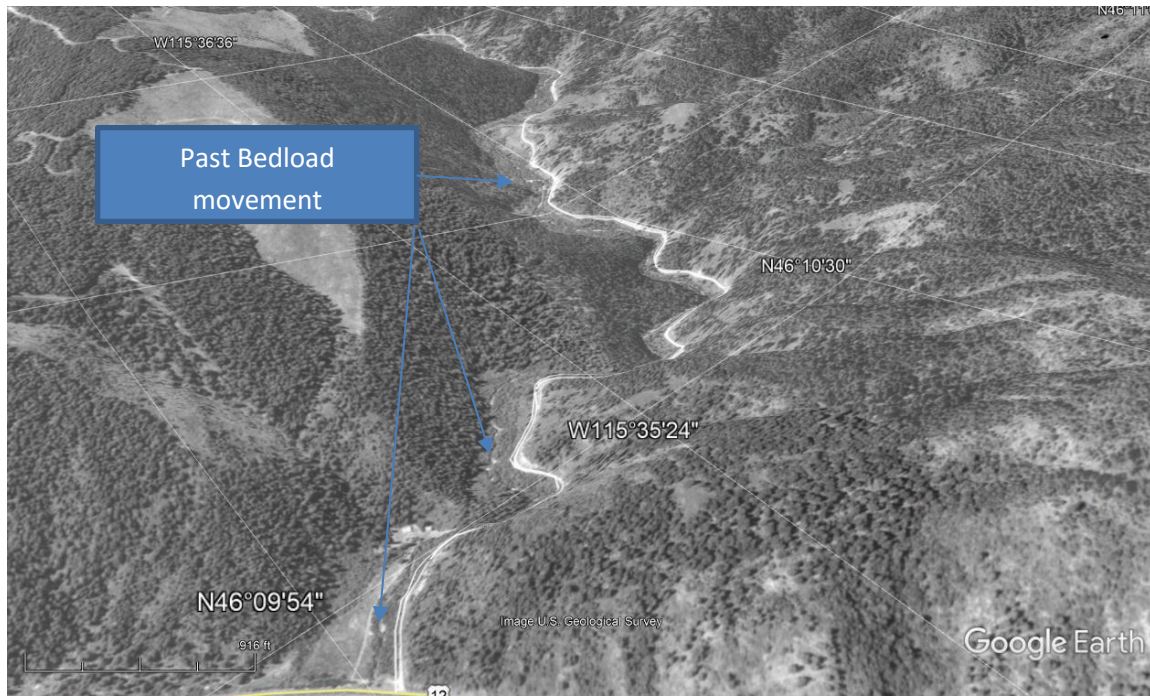
Photo 3: Pete King Creek Assessment Reach 1 mid 1990s Photo. Showing very little change in channels over time indicating stability and upward trend considering greater abundance of stream side vegetation today (compare photo 2 and 3) and less gravel bars today indicating less bedload movement and stable channel.

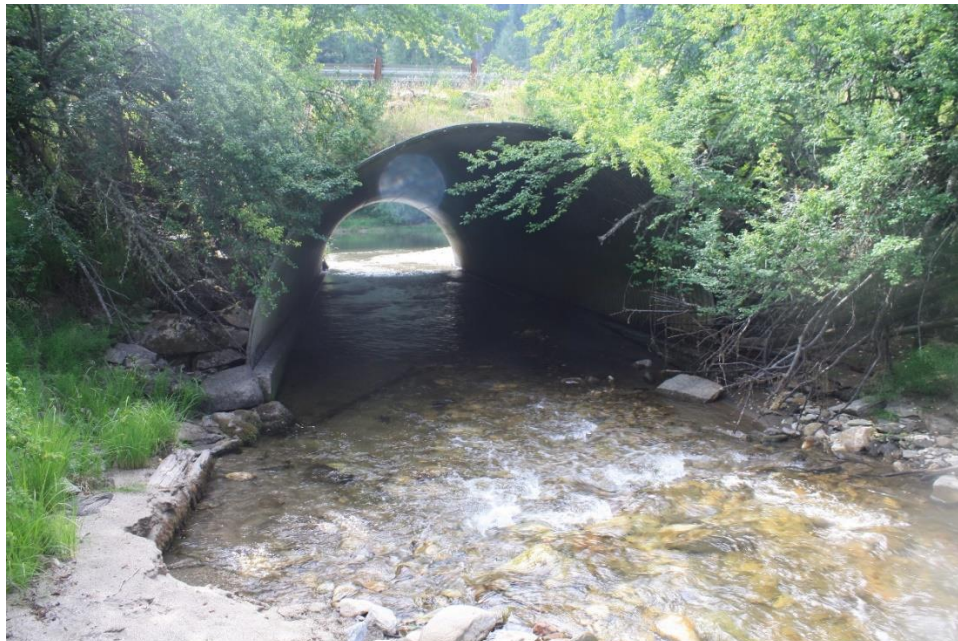
Photo 4 Reach 1: Pete King Confluence with the Locsha River. Stable and functioning road stream crossing.

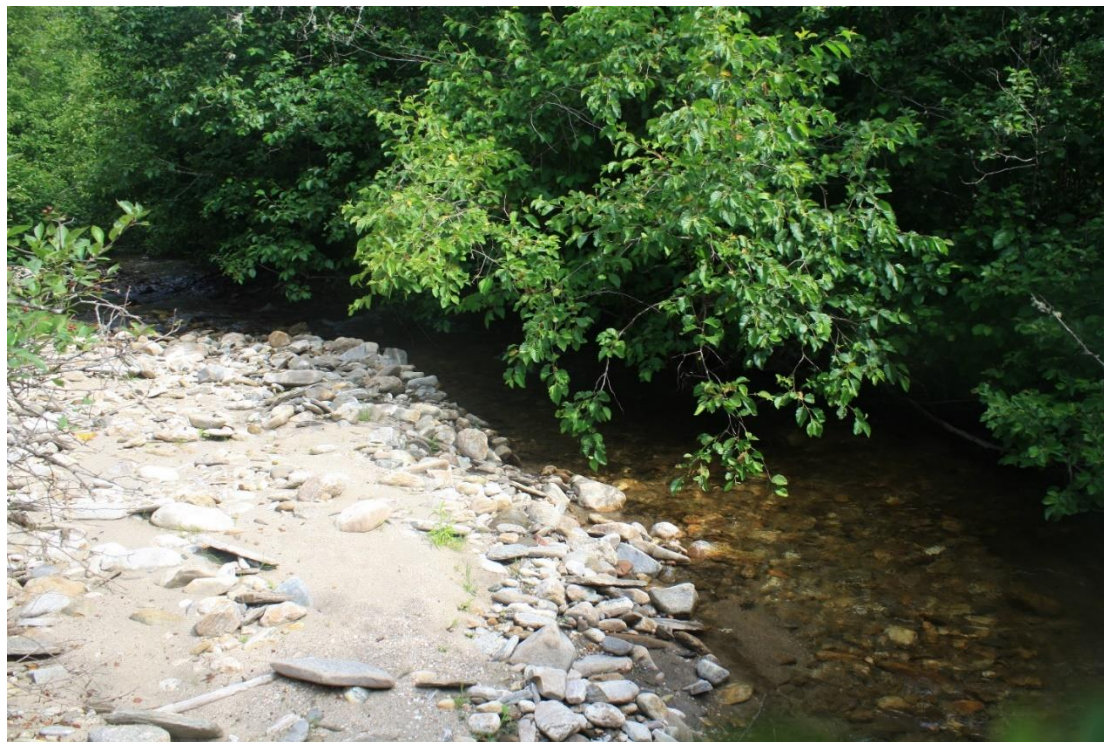
Photo 5 Reach 1: Pete King showing heavy vegetation on stream banks for stability and shade

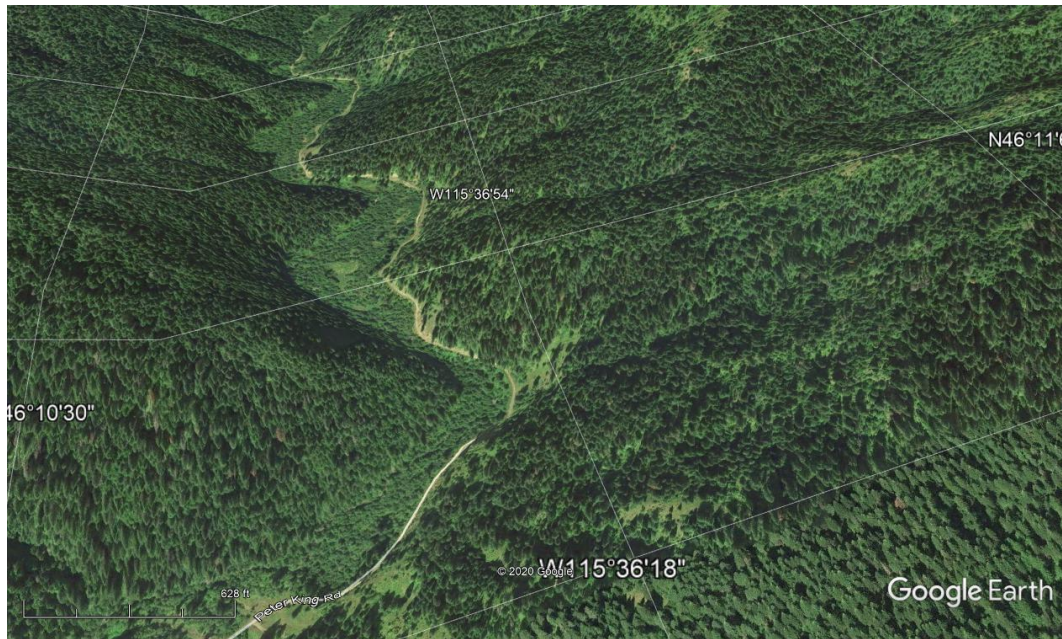
**Pete King Assessed Reach 2 (~5500ft):** This reach flows through Forest Service land in the lower end of the watershed. This appears to have had some riparian harvest (likely in the 1970s) previously given old cedar stumps. This harvest is estimated at well over 50 years ago long before modern riparian buffers were required. Residual materials derived from resistant rock types such as colluvium and or alluvium adds significant control and adequate sources of existing and recruitment of large wood (LWD) as well as healthy amounts of riparian-wetland vegetation has help maintain channel/stream bank stability. This reach and will most likely remain resistant to large scale evulsions and catastrophic disturbances such as large flood events. There is enough channel and floodplain vegetation, soils or land form characteristics to withstand large flood events without significantly damaging the riparian corridor. Channel in confined in areas due to valley form. The channel is relatively stable vertically and laterally (photo 6, 7, 8, and 9) which means it has limited ability to laterally scour and or vertically scour or down-cut. The channel type of this reach is primarily a Rosgen “B”. Channel slopes for this type typically range from 5-10%, substrate ranges from cobbles and boulders to a mix of gravels and small gravel alluvium. No major evulsions or aggradation of bedload were observed. The stream habitat in this reach is influenced heavily by riparian vegetation and some large woody debris which has produced scour pools and riffles. Large woody debris (LWD) is an integral part of this type of stream system. LWD and stream bank vegetation dissipates erosive energy, controls bedload transport, stabilizes stream channels, and creates suitable habitat for fish and other aquatic organisms. Vegetated point bars and substrate indicate stable hydrologic process. The stream channel is shaded mostly by a dense over-story of mature deciduous trees and brush but limited adjacent LWD recruitment. Moss on in stream wood and rocks indicate moderate to low erosive stream hydrology. In summary this stream channel reach, just below the project area and therefore most subject to effects, should remain in a stabilized condition and should continue to improving in complexity and stability over time and trend toward desired conditions for aquatic habitat (i.e. lower embeddedness) as existing fine sediments move out of the system and minimal

This reach is rated as **Proper Function Condition (PFC)**

Photo 6: Pete King Creek Assessment Reach 2 ( $46^{\circ}10'24.34''$  N  $115^{\circ}37'49.50''$  W)

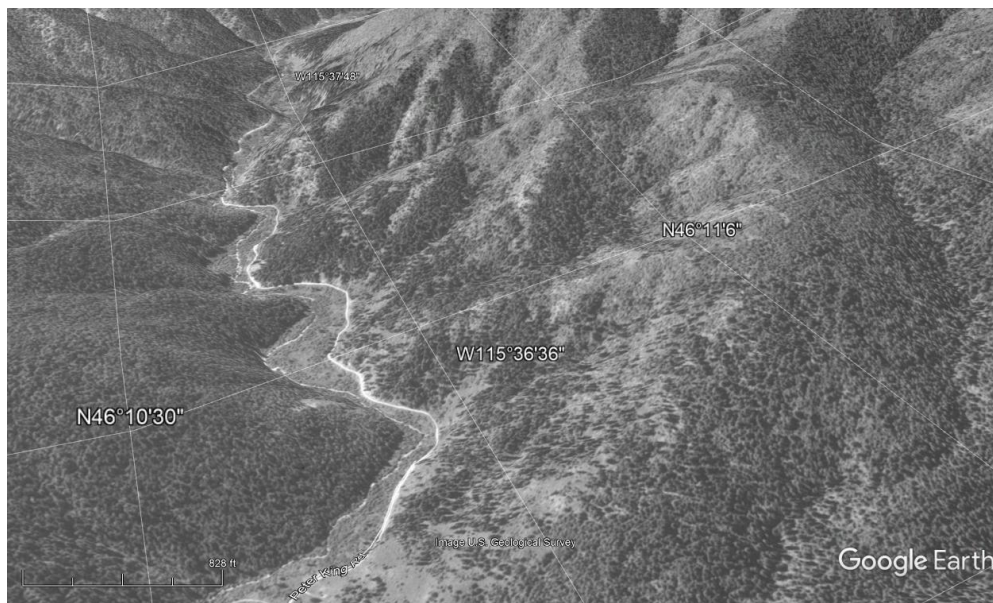
Photo 7: Pete King Creek Assessment Reach 1 mid 1990s Photo. Showing very little change in channels over time indicating stability and upward trend considering greater abundance of stream side vegetation today (compare photo 6 and 7) and less gravel bars indicating less bedload movement.

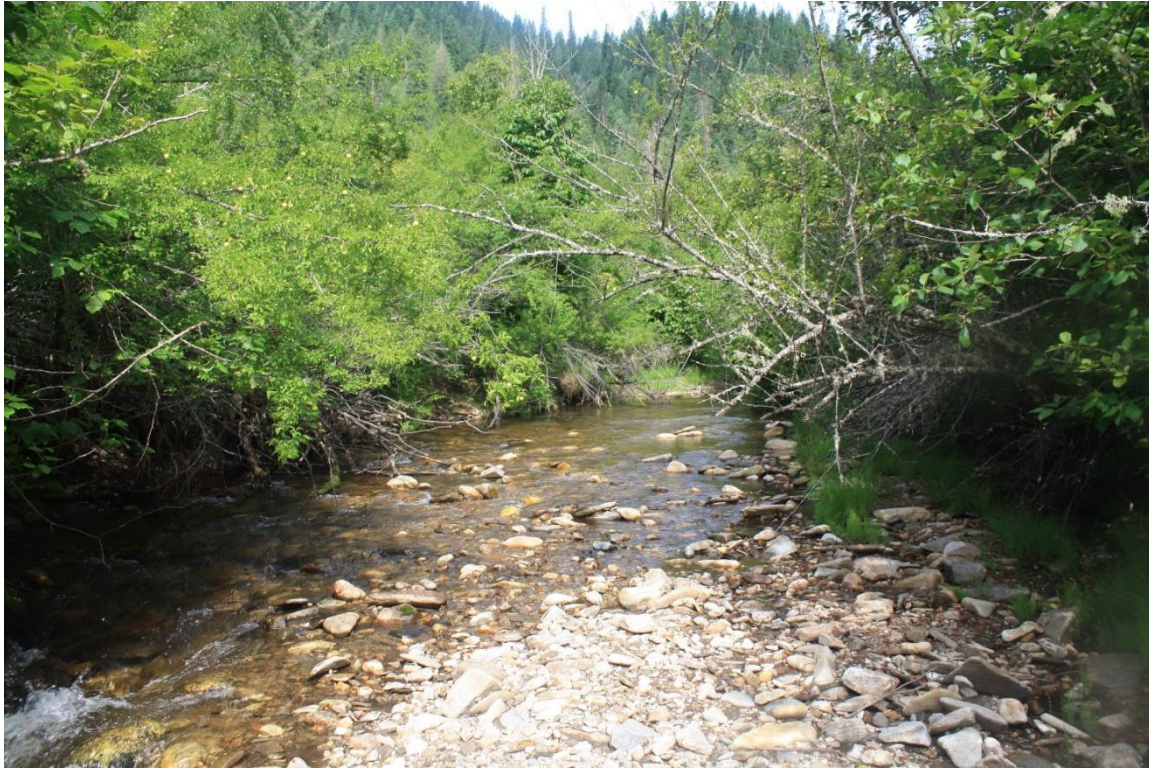
Photo 8 Reach 2: Pete King showing heavy vegetation on stream banks for stability and shade. Stream banks are stable and there is vegetation growing on point bars indicating channel stability and resiliency to high flow events.

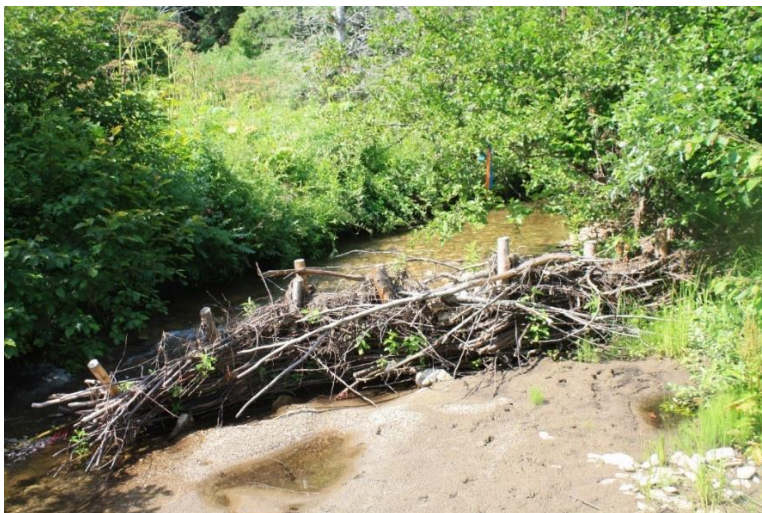
Photo 9 Reach 2: Pete King showing past stream enhancement project aiding sedimentation dispersion and promoting point bar formation and vegetation. Heavy vegetation on stream banks for stability and shade. Stream banks are stable and there is vegetation growing on point bars indicating channel stability and resiliency to high flow events.

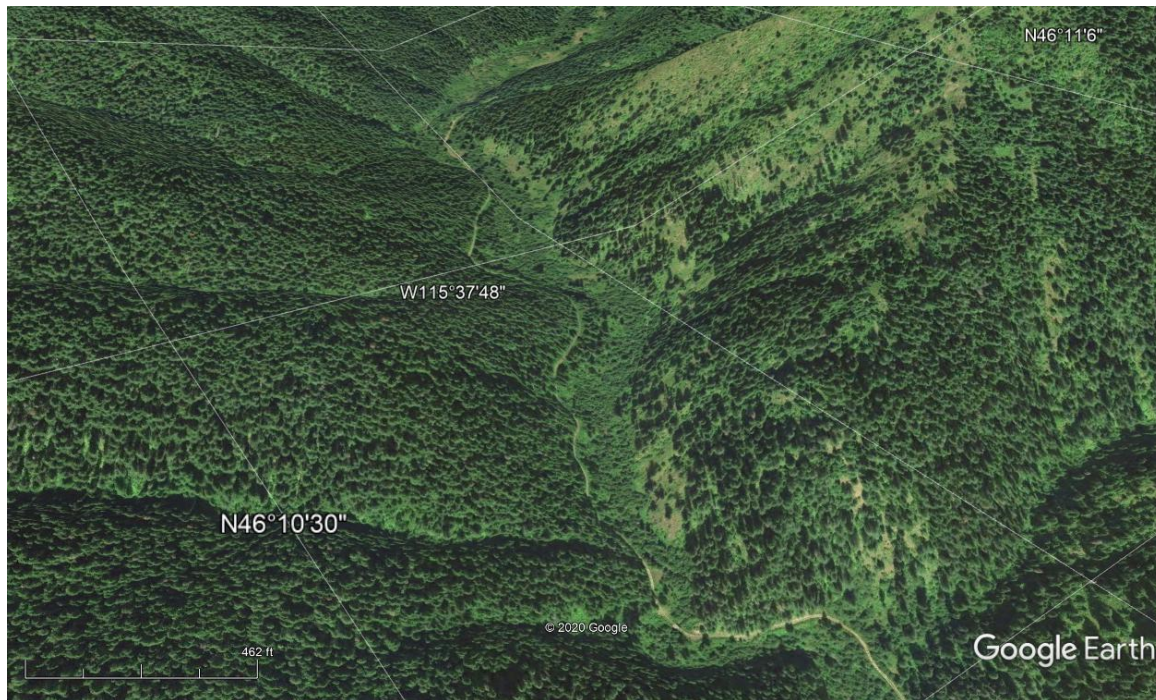
**Pete King Assessed Reach 3 (~4255ft):** This reach flows through Forest Service land in the middle portion of the watershed. This appears to have had some riparian harvest (likely in the 1970s) previously given old cedar stumps. This harvest is estimated at well over 50 years ago long before modern riparian buffers were required. Residual materials derived from resistant rock types such as colluvium and or alluvium adds significant control and adequate sources of existing and recruitment of large wood (LWD) as well as healthy amounts of riparian-wetland vegetation has help maintain channel/stream bank stability. This reach and will most likely remain resistant to large scale evulsions and catastrophic disturbances such as large flood events. There is enough channel and floodplain vegetation, soils or land form characteristics to withstand large flood events without significantly damaging the riparian corridor. Channel is confined in areas due to valley form. The channel is relatively stable vertically and laterally (photo 10, 11, 12, 13 and 14) which means it has limited ability to laterally scour and or vertically scour or down-cut. The channel type of this reach is primarily a Rosgen “B”. Channel slopes for this type typically range from 8-12%, substrate ranges from cobbles and boulders to a mix of gravels and small gravel alluvium. No major evulsions or aggradation of bedload were observed. The stream habitat in this reach is influenced heavily by riparian vegetation and some large woody debris which has produced scour pools and riffles. Large woody debris (LWD) is an integral part of this type of stream system. LWD and stream bank vegetation dissipates erosive energy, controls bedload transport, stabilizes stream channels, and creates suitable habitat for fish and other aquatic organisms. Vegetated point bars and substrate indicate stable hydrologic process. The stream channel is shaded mostly by a dense over-story of mature deciduous trees and brush but limited adjacent LWD recruitment. Moss on in stream wood and rocks indicate moderate to low erosive stream hydrology. In summary this stream channel reach, just below the project area and therefore most subject to effects, should remain in a stabilized condition and should continue to improving in complexity and stability over time and trend toward desired conditions for aquatic habitat (i.e. lower embeddedness) as existing fine sediments move out of the system and minimal fines are input. The fish habitat suitability (pools, complexity, clean water and shade) in this reach should be maintained or improved over time given the protective riparian buffers which will remain intact.

This reach is rated as **Proper Function Condition (PFC)**

Photo 10: Pete King Creek Assessment Reach 3 (46°10'47.09"N 115°38'41.34" W)

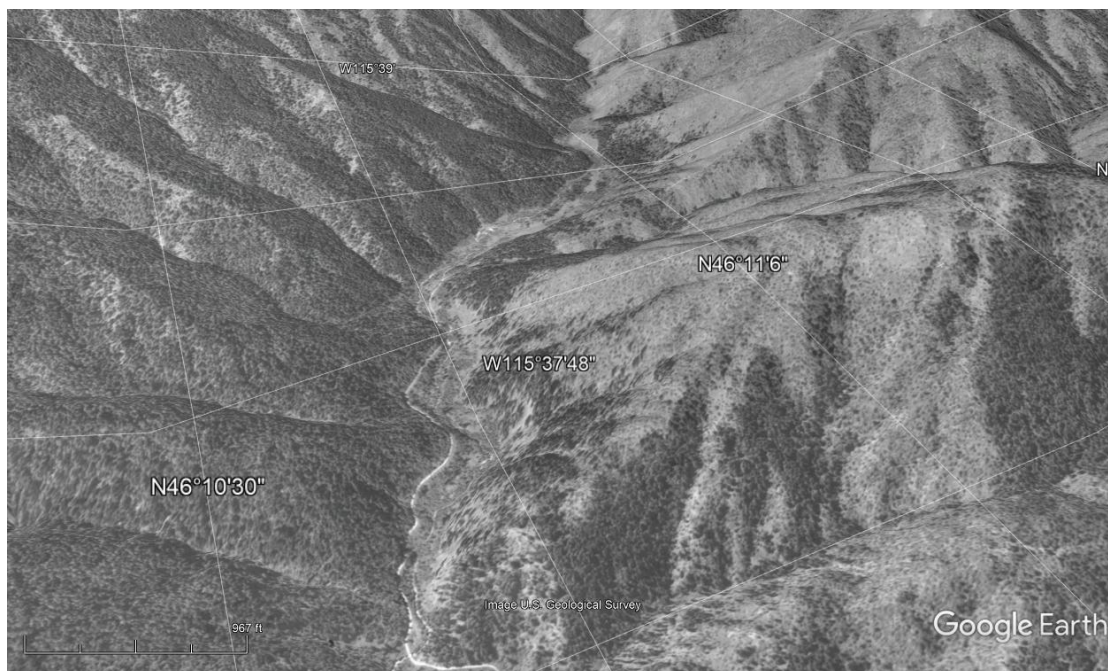
Photo 11: Pete King Creek Assessment Reach 1 mid 1990s Photo. Showing very little change in channels over time indicating stability and upward trend considering greater abundance of stream side vegetation today (compare photo 10 and 11) and less gravel bars indicating less bedload movement.

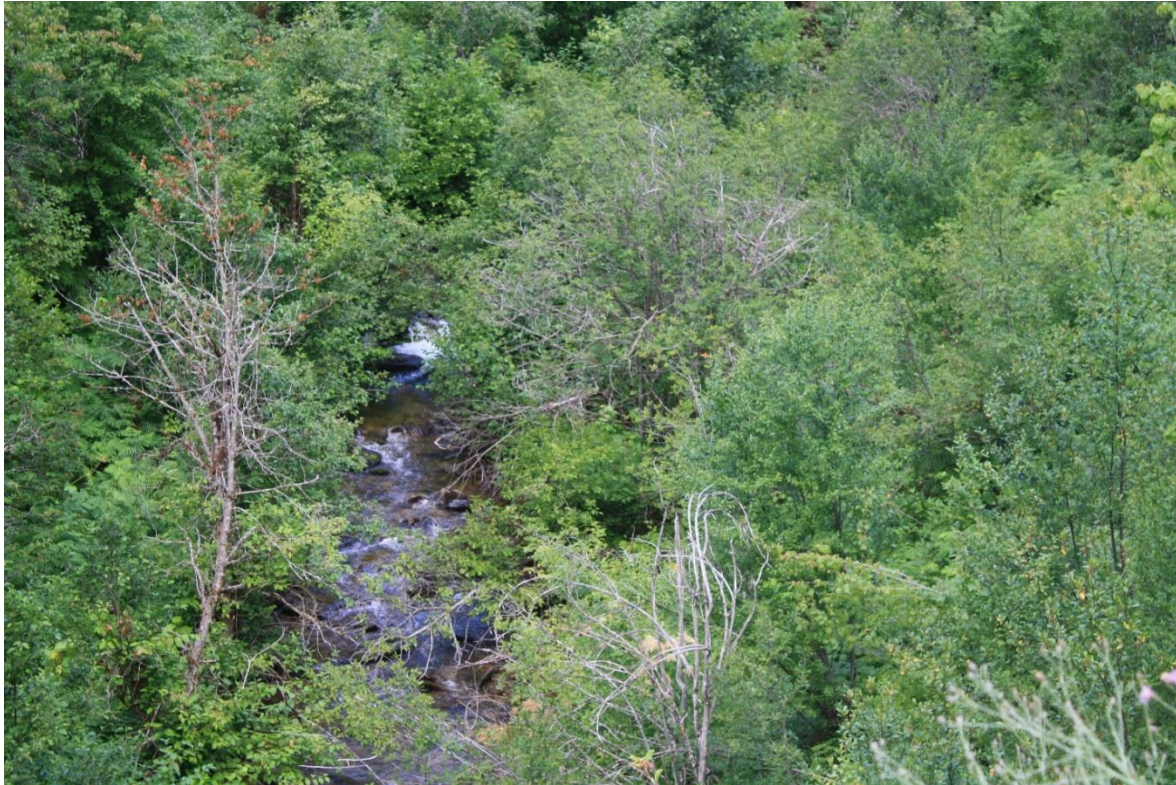
Photo 12 Reach 3: Pete King showing heavy vegetation on stream banks for stability and shade. Stream banks are stable. Channel type and substrate indicating high channel stability and resiliency to high flow events.

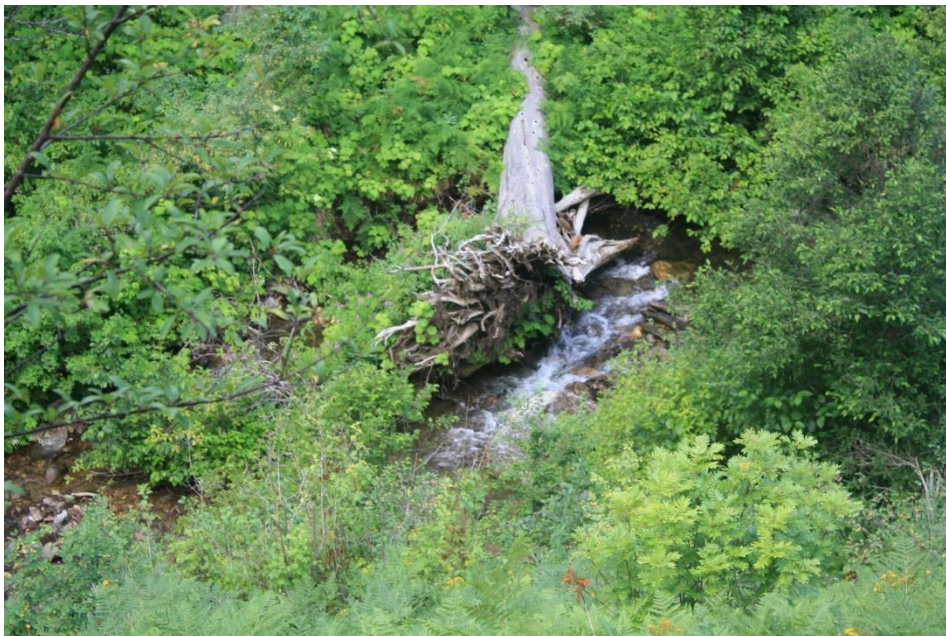
Photo 13 Reach 3: Pete King showing heavy vegetation on stream banks for stability and shade. Stream banks are stable. LWD plays a key role in habitat formation. Channel type inherently stable.

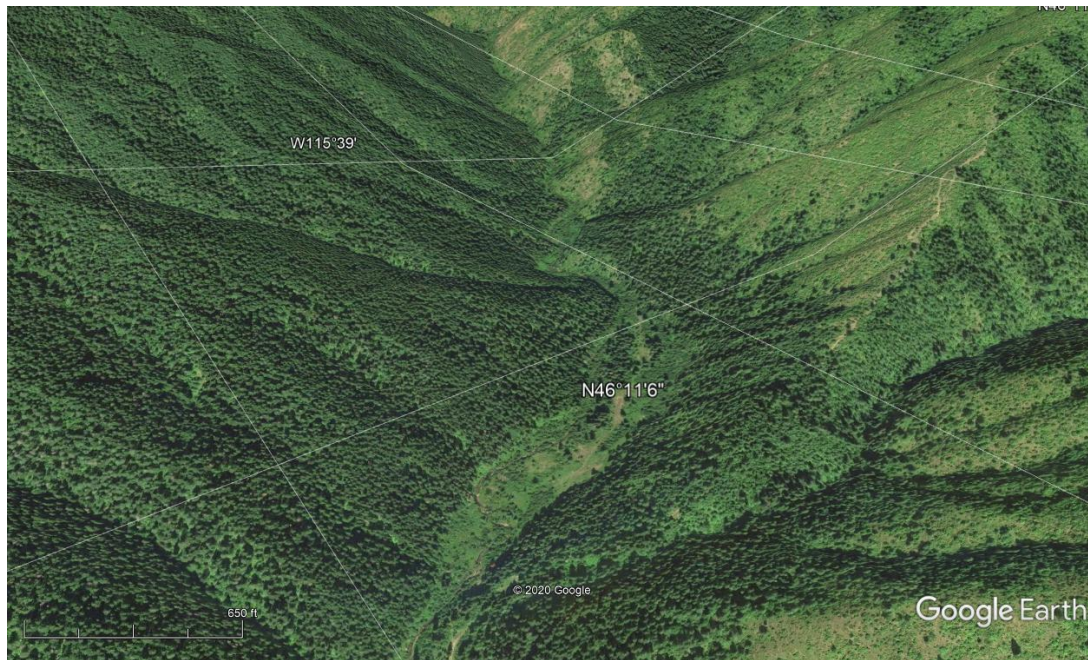
**Pete King Assessed Reach 4 (~8295ft):** This reach flows through Forest Service land in the middle portion of the watershed. Residual materials derived from resistant rock types such as colluvium and or alluvium adds significant control and adequate sources of existing and recruitment of large wood (LWD) as well as healthy amounts of riparian-wetland vegetation has help maintain channel/stream bank stability. This reach and will most likely remain resistant to large scale evulsions and catastrophic disturbances such as large flood events. There is enough channel and floodplain vegetation, soils or land form characteristics to withstand large flood events without significantly damaging the riparian corridor. Channel in confined in areas due to valley form. The channel is relatively stable vertically and laterally (photo 14-18) which means it has limited ability to laterally scour and or vertically scour or down-cut. The channel type of this reach is primarily a Rosgen “B”. Channel slopes for this type typically range from 8-12%, substrate ranges from cobbles and boulders to a mix of gravels and small gravel alluvium. No major evulsions or aggradation of bedload were observed. The stream habitat in this reach is influenced heavily by riparian vegetation and some large woody debris which has produced scour pools and riffles. Large woody debris (LWD) is an integral part of this type of stream system. LWD and stream bank vegetation dissipates erosive energy, controls bedload transport, stabilizes stream channels, and creates suitable habitat for fish and other aquatic organisms. Vegetated point bars and substrate indicate stable hydrologic process. The stream channel is shaded mostly by a dense over-story of mature deciduous trees and brush but limited adjacent LWD recruitment. Moss on in stream wood and rocks indicate moderate to low erosive stream hydrology. In summary this stream channel reach, just below the project area and therefore most subject to effects, should remain in a stabilized condition and should continue to improving in complexity and stability over time and trend toward desired conditions for aquatic habitat (i.e. lower embeddedness) as existing fine sediments move out of the system and minimal fines are input. The fish habitat suitability (pools, complexity, clean water and shade) in this reach should be maintained or improved over time given the protective riparian buffers which will remain intact.

This reach is rated as **Proper Function Condition (PFC)**

Photo 14: Pete King Creek Assessment Reach 4 -  $46^{\circ}10'47.09''\text{N}$   $115^{\circ}38'41.34''\text{W}$

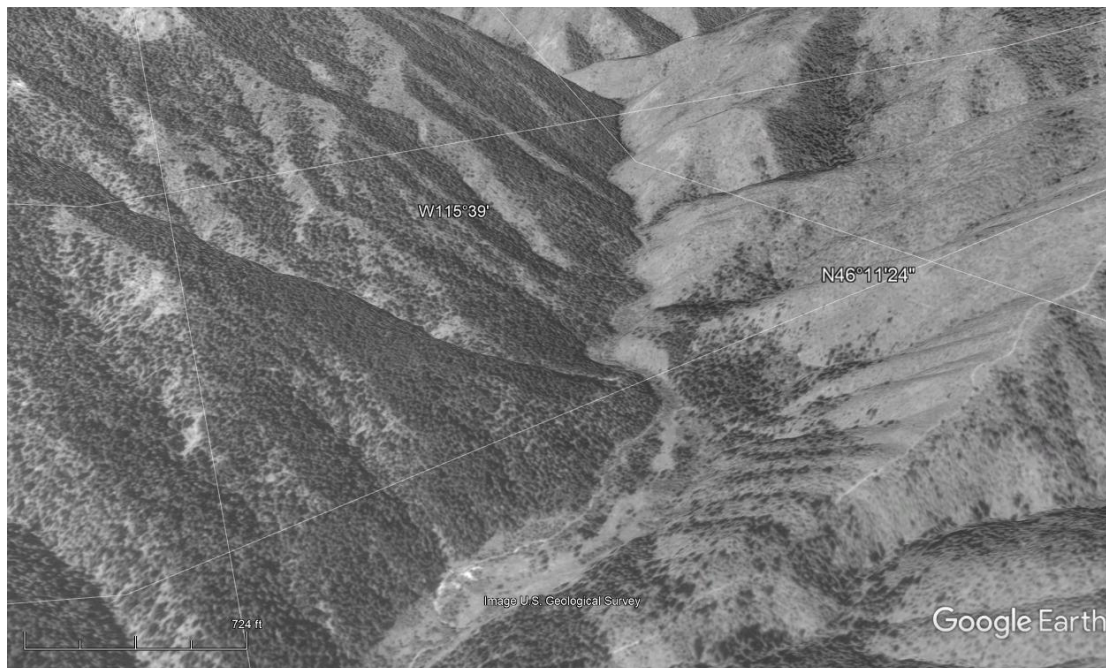
Photo 15: Pete King Creek Assessment Reach 4 mid 1990s Photo. Showing very little change in channels over time indicating stability and upward trend considering greater abundance of stream side vegetation today (compare photo 15 and ) and less gravel bars indicating less bedload movement.

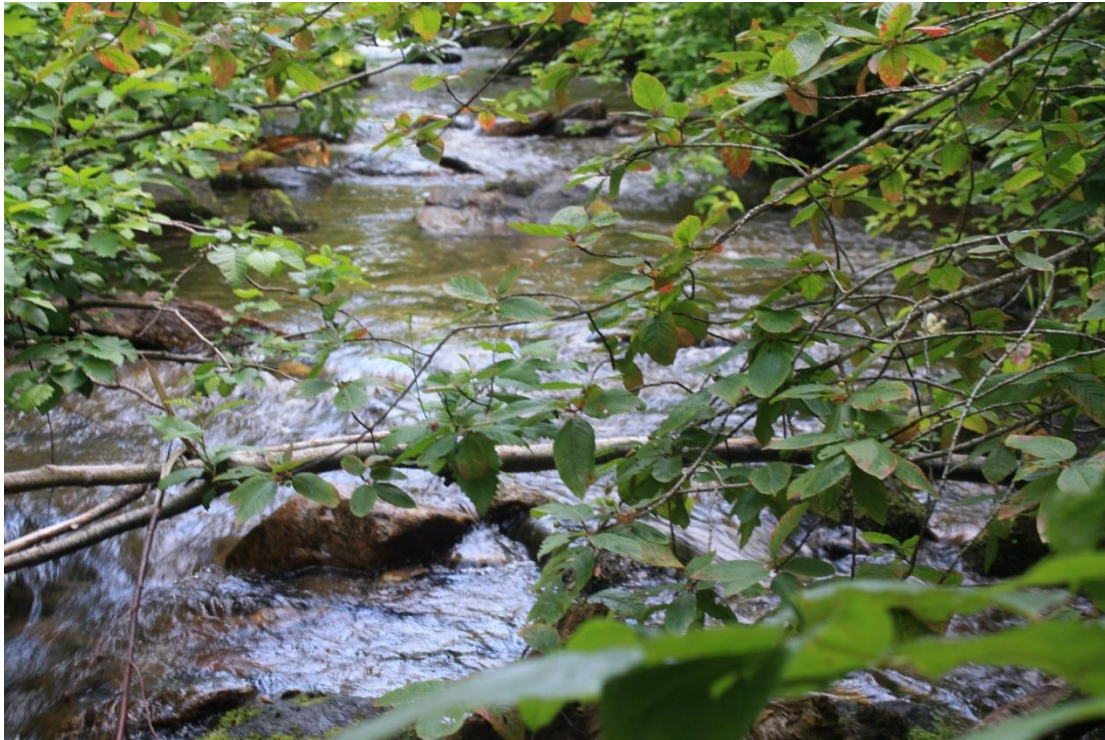
Photo 16 Reach 4: Pete King showing heavy vegetation on stream banks for stability and shade. Stream banks are stable. High channel stability and resiliency to high flow events given inherency of channel type.

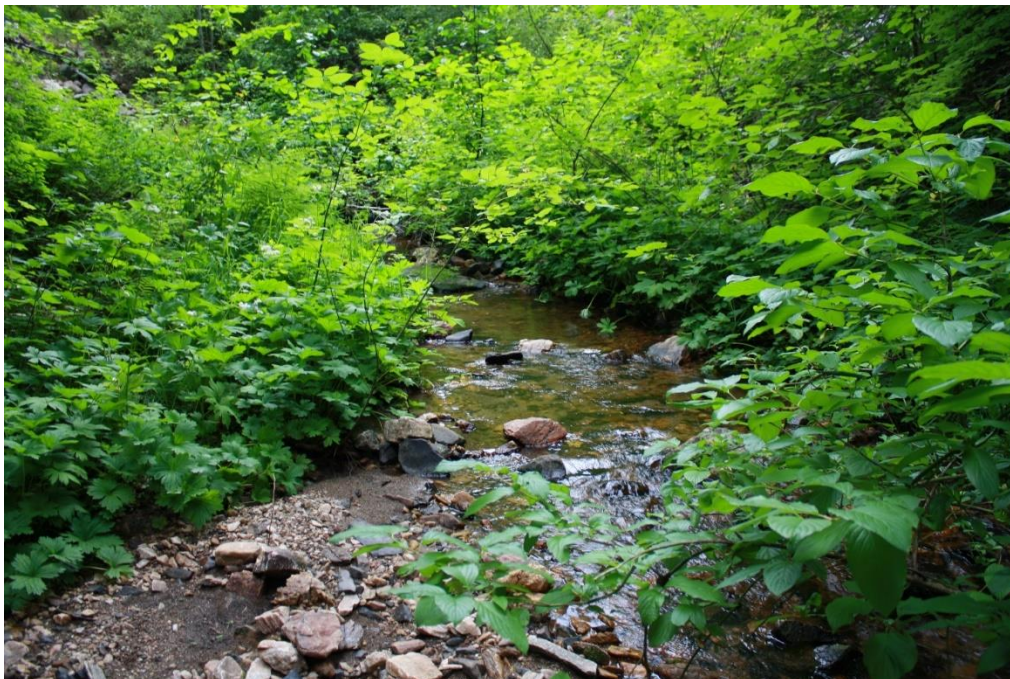
Photo 17 Reach 4: Pete King showing heavy vegetation on stream banks for stability and shade. Channel stability and resiliency to high flow events is high.

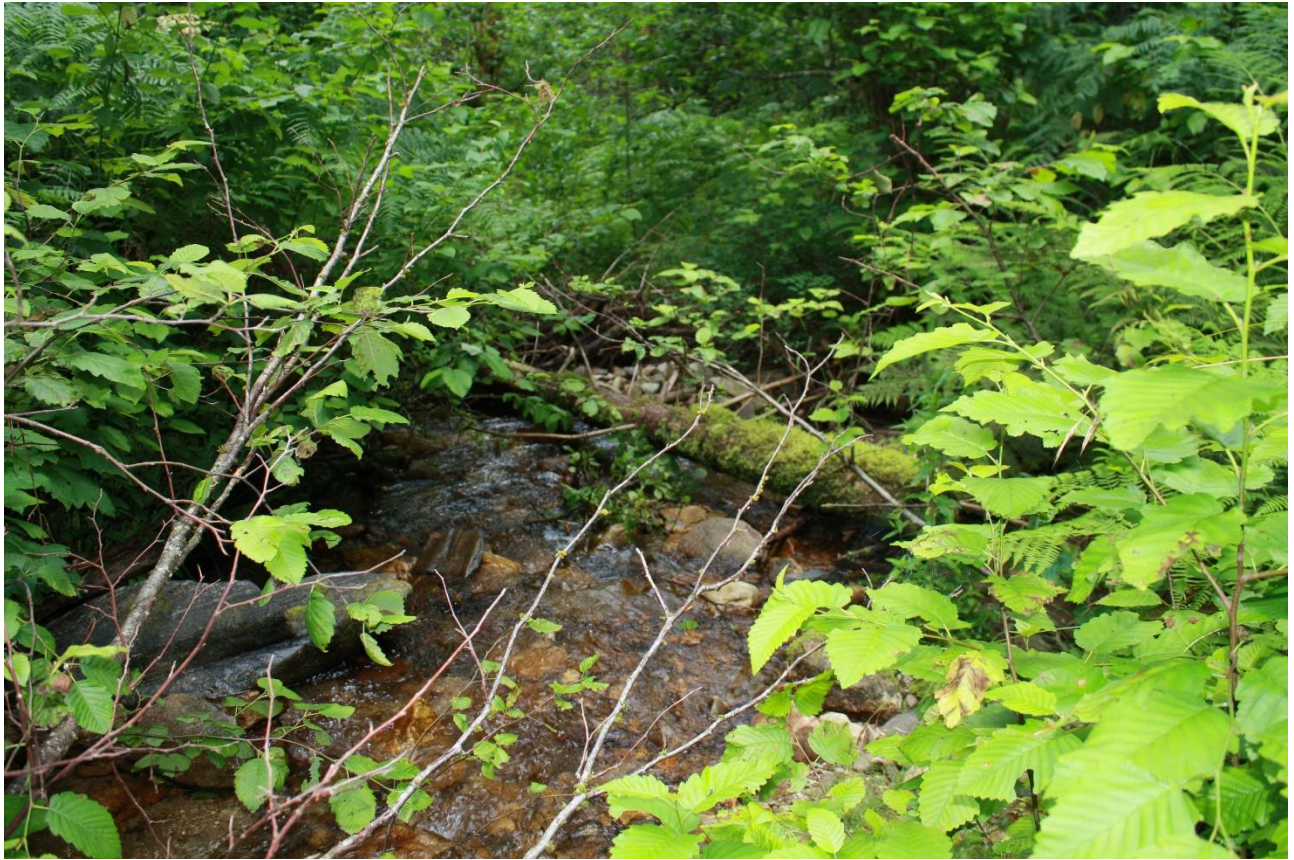
Photo 18 Reach 4: Pete King showing heavy vegetation on stream banks for stability and shade. Stream banks are stable. LWD plays a key role in habitat formation. Channel type inherently stable.

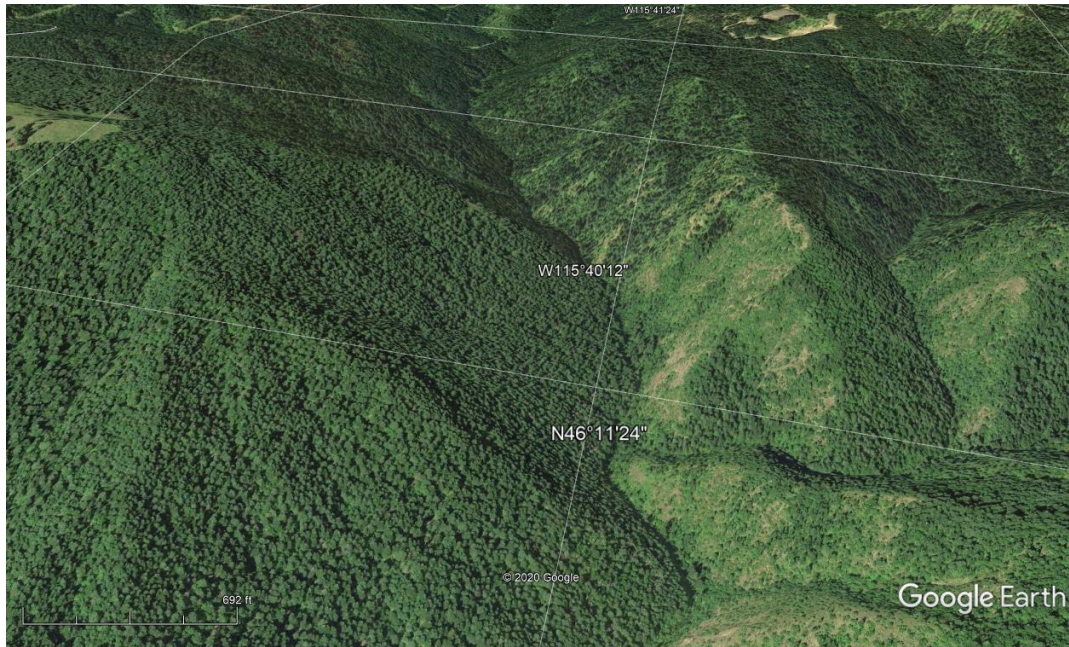
**Pete King Assessed Reach 5 (~8700ft):** The channel type of this reach is primarily a Rosgen “B”. Channel slopes for this type typically range from 8-12%, substrate is a mix of cobbles and gravel alluvium. The stream habitat in this reach is influenced heavily by large woody debris which has produced scour pools and riffles (Photo 22 and 23). Large woody debris (LWD) is an integral part of this type of stream system. LWD dissipates erosive energy, controls bedload transport, stabilizes stream channels, and creates suitable habitat for fish and other aquatic organisms. The stream channel is shaded by a dense overstory of mature cedar and fir trees that also provide LWD recruitment. Moss on in stream wood and rocks indicate moderate to low erosive stream hydrology. In summary this stream channel reach, adjacent to the project area and therefore most subject to effects should, given the RHCA buffers, remain in a stabilized condition and should continue to improve in complexity and stability over time and trend toward desired conditions for aquatic habitat as existing fine sediments move out of the system and minimal fines are input. The fish habitat suitability (pools, complexity, clean water and shade) in this reach should be maintained or improved over time given the protective riparian buffers which will remain intact.

This reach is rated as **Proper Function Condition (PFC)**

Photo 19: Pete King Creek Assessment Reach 5 (46°11'23.53"N 115°40'04.83" W)

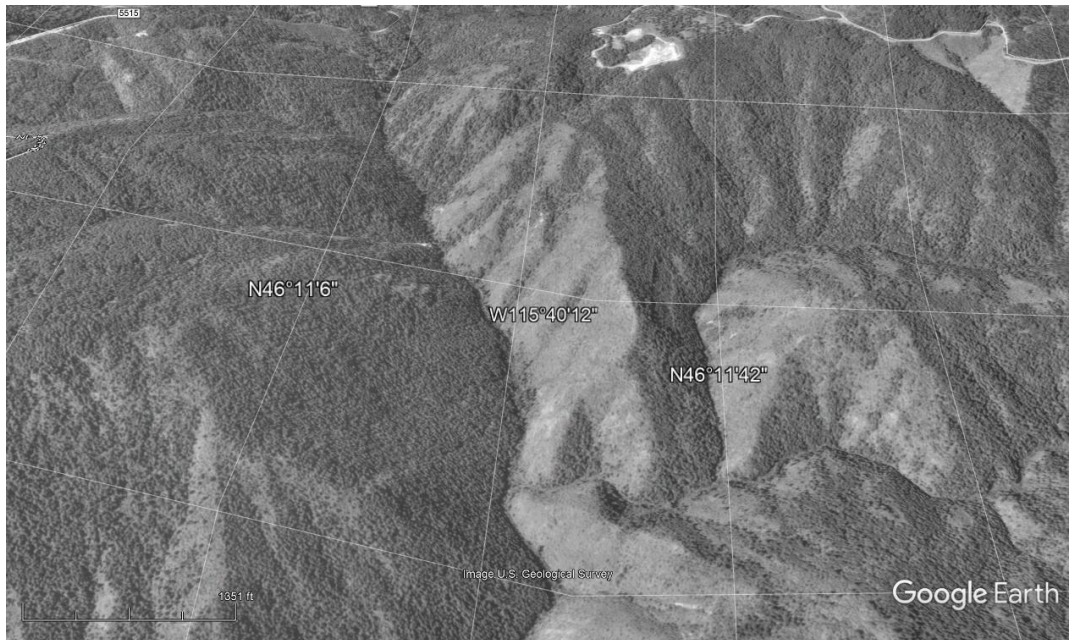
Photo 20: Pete King Creek Assessment Reach 4 mid 1990s Photo. Showing very little change in channels over time indicating stability and upward trend considering greater abundance of stream side vegetation today (compare photo 2 and 3) and less gravel bars indicating less bedload movement.

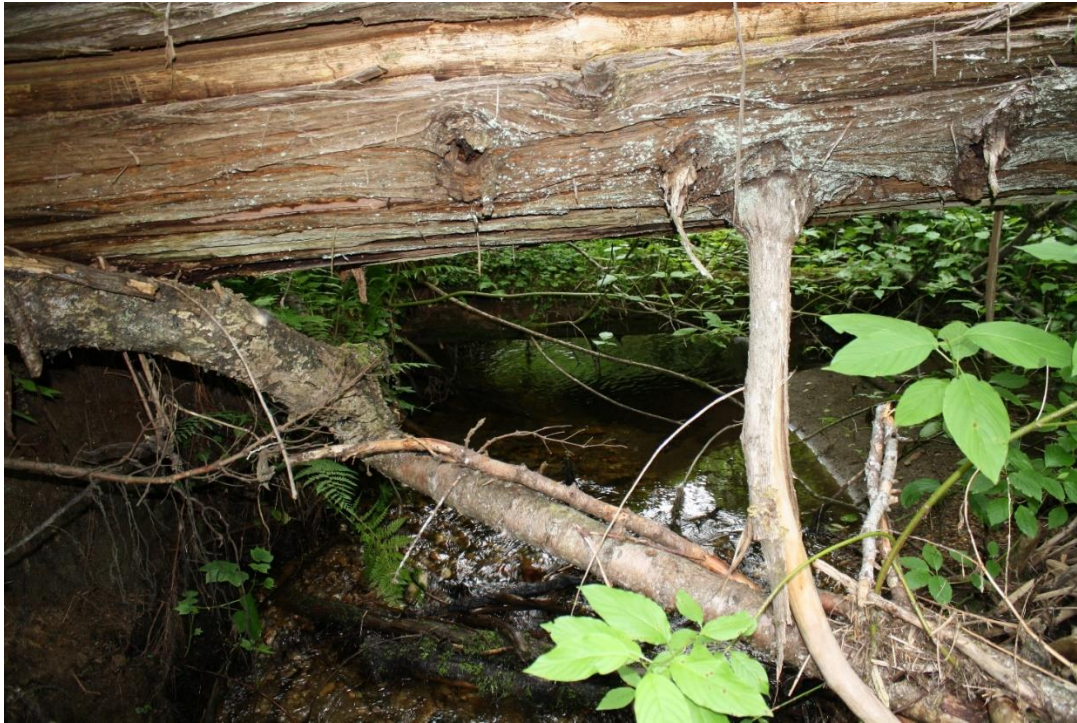
Photo 21 Reach 5: Pete King showing heavy vegetation on stream banks for stability and shade. Stream banks are stable. LWD plays a key role in fish habitat formation. Channel type inherently stable.

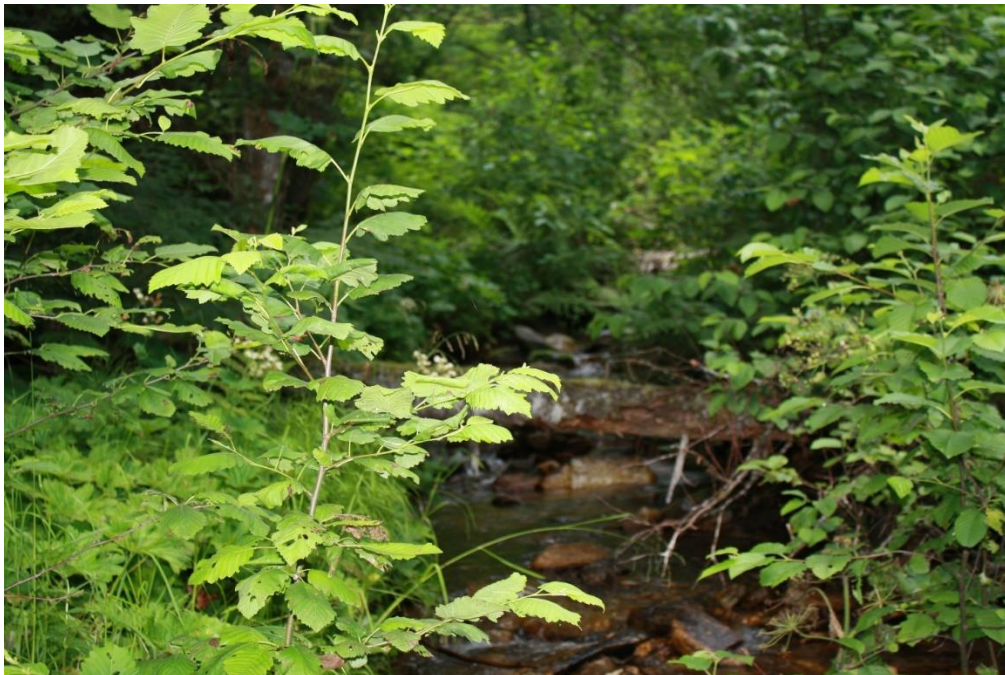
Photo 22 Reach 5: Pete King showing heavy vegetation on stream banks for stability and shade. Channel stability and resiliency to high flow events is high.

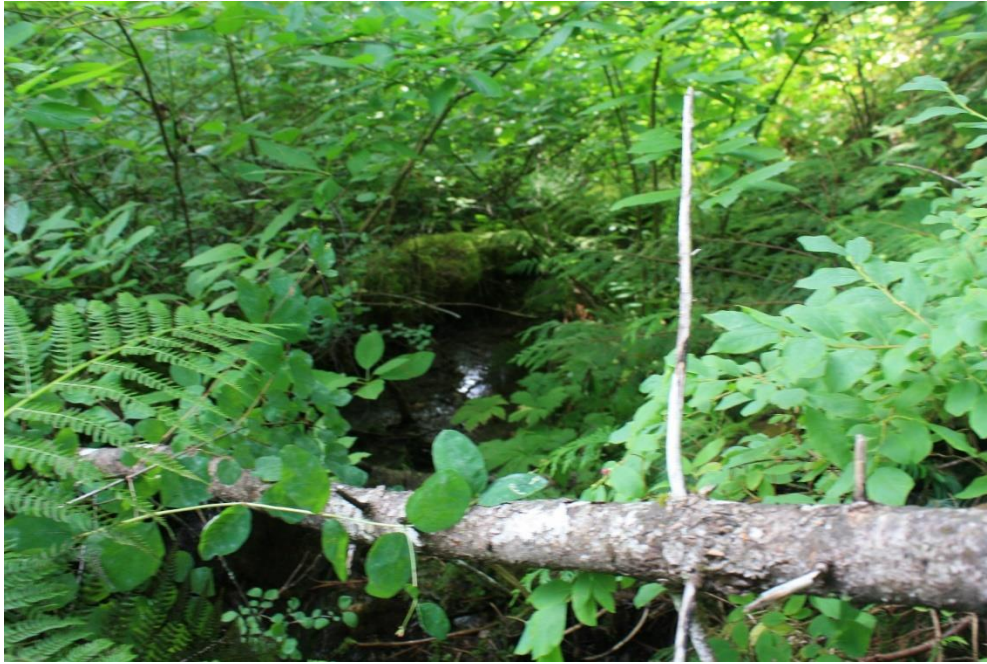
Photo 23 Reach 5: Pete King showing heavy vegetation on stream banks for stability and shade. Channel stability and resiliency to high flow events is high. Moss on wood and rock indicate stable stream channel and flows.
